## Restoration Guide Post 60k TR3A through TR3B

**Category:** Underhood

**Example Shown:** TCF TR3B

**Component(s):** Steering, Tachometer Cable, Washer Bottle Hose, Fender Mounting Plate

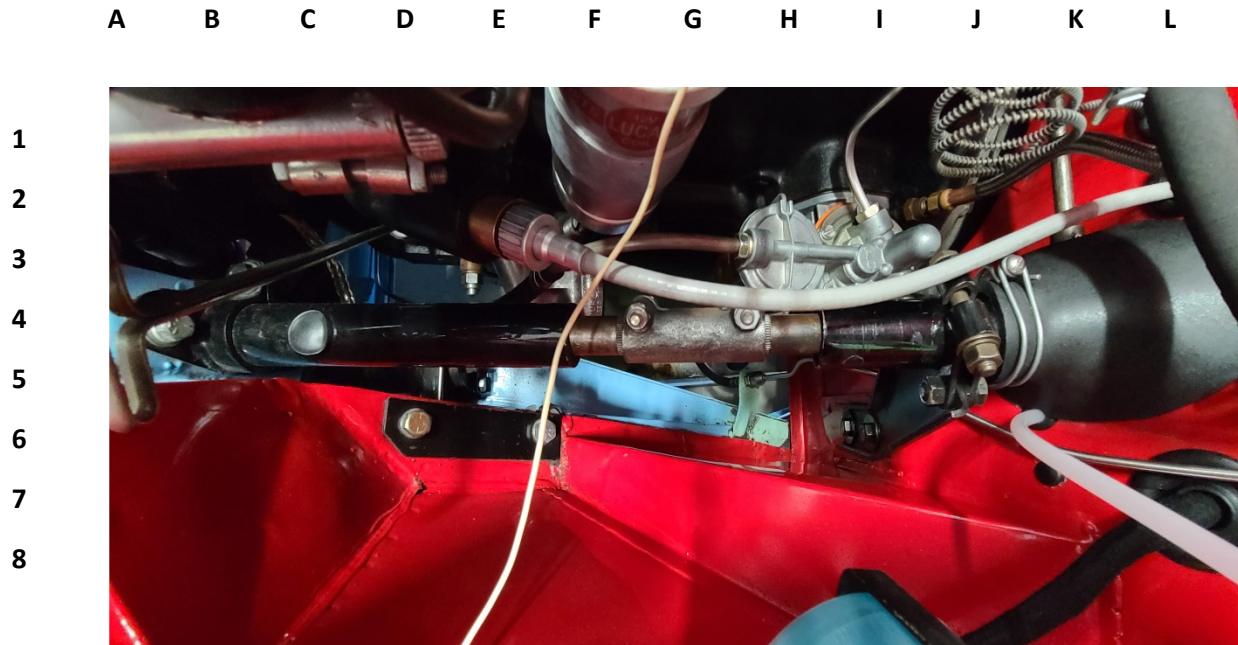
**Discussion:** At G4, Split steering clamp and exposed inside shaft are natural finish, rest of shaft is painted gloss black.

At C4, rubber plug covers steering box fluid fill hole.

At J5, Upper support bracket painted gloss black, was added with split steering.

At K4, rubber steering boot attached with wire clamp.

At E2, grey tachometer cable attached to distributor pedestal, earlier cars had black cables.

At J5, shown is the routing for white washer bottle hose, not necessarily correct. Hose may be routed almost anywhere through the bulkhead, preferable further to the passenger side, closer to the washer pump.

At D6, Inner fender mounting plate is painted semi-gloss black.
