# **Triumph Register of America**

## **Concours d'Elegance**

### ***Judge's Guidelines***

***TR2 – TR3B***

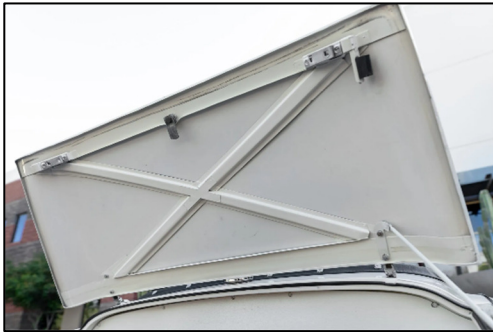
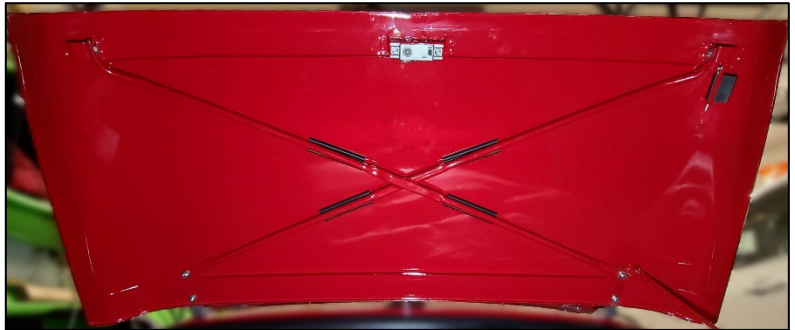
*Left photo is of the underside of a TR2-3 boot lid. Right photo is of a post-TS60000 TR3A- TR3B.*

*From TS60000*, tubular ‘X’ support braces with underlying black foam rubber pads replaced the earlier stamped and welded supports. The hinge attachment points now had a slightly raised bezel following the contour of the hinge.

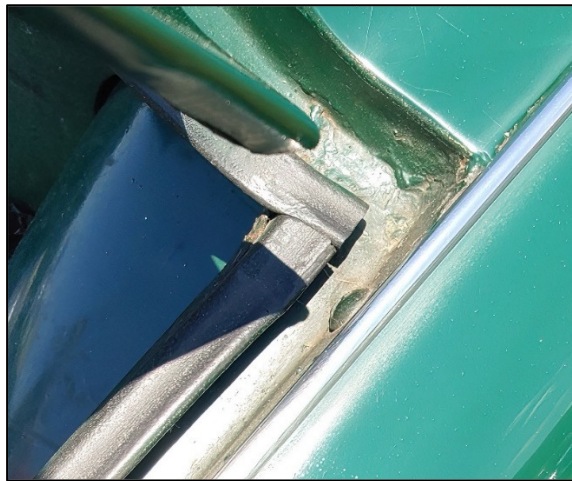
*Pre-TS60000 2-piece boot seal joint on RH top of boot opening, the other joint is on LH side.*

*From TS1*, these were two pieces of the same stock glued into a ‘double walled’ channel surrounding the boot opening. One piece ran along the sides and back channel, with the ‘high’ portion of the seal facing outward. A second ran along the front channel, with the ‘high’ portion of the seal facing inward, possibly to reduce fouling on the hinge mounting studs. As these seals were hand cut and applied, the adjoining seams between the two at the upper corners of the drip channel varied, the most common having the ‘upper’ seal running the full length of the channel with the longer piece butting into its side.

*From TS60000*, the boot lid seal changed with the body retooling, and was now a single piece pressed onto a single raised lip with the ‘ends’ centered at the rear of the boot lid opening or at the top just below the gas cap with the ‘high’ portion of the seal facing outward.
