# **Triumph Register of America**

## **Concours d'Elegance**

### ***Judge's Guidelines***

***TR2 – TR3B***

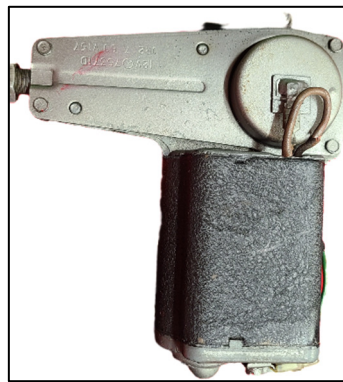
*TS12567*: Lucas DR2 windscreen wiper motor replaces CRT and is now mounted on the left side

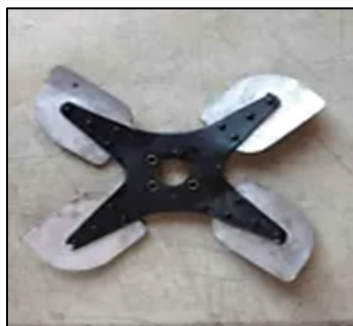
*Stock four bladed fan*

***Tropical Cooling Fans:*** Introduced during TR4 production, these six bladed fans are constructed as 'standard' four bladed fans, and attach without modification to a TR2-3B engine, often with significant cooling advantages..

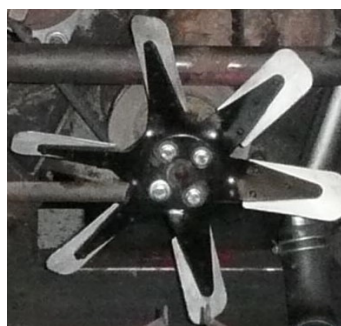
*Tropical six bladed fan*

***Do not deduct for properly finished factory aluminum bladed tropical fans.***
