## Restoration Guide Post 60k TR3A through TR3B

**Category:** Underhood

**Example Shown:** TCF TR3B

**Component(s):** Fuel Pump, Oil Filter Detail

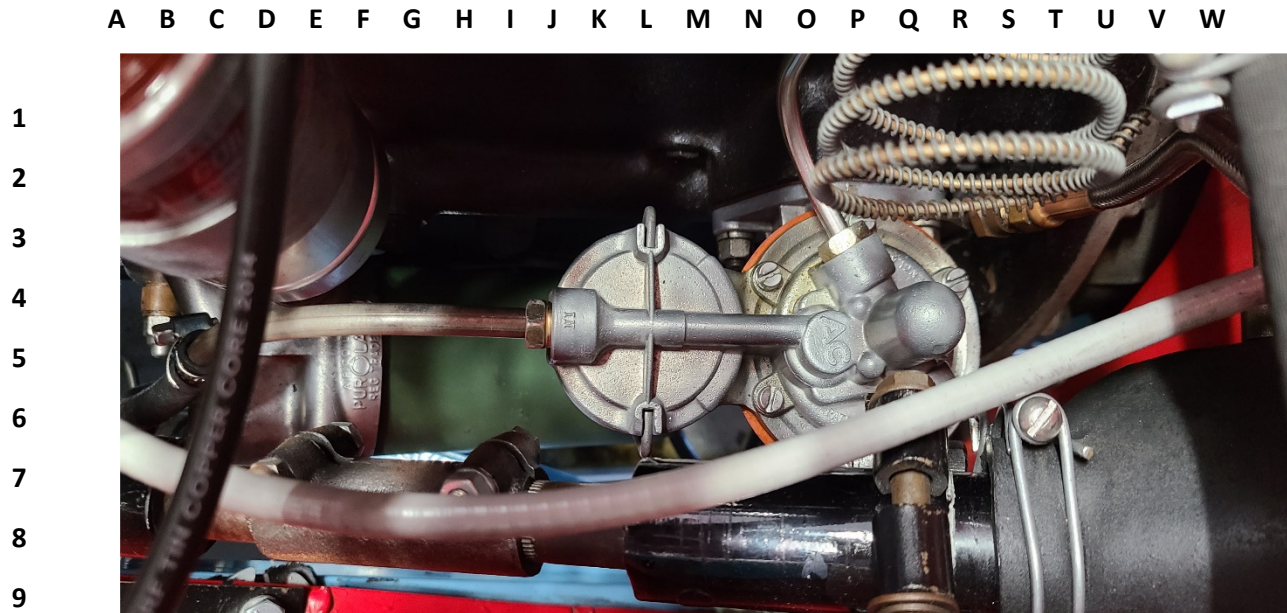
**At O5:** AC brand embossed fuel pump with natural finish attached to mild steel fuel lines. Primer lever not shown. On right side of the pump is a P-clip mounted through the bolt that attaches the pump to the block. The clip holds the oil pressure line in place. Tip: If tab on diaphragm is stiff and brittle it's time to rebuild the pump!

**At F6:** Purolator "full-flow" oil filter head finished naturally.

**At G6:** Oil filter canister, color originally light blue but with age develops a teal green patina.

**At E8:** Another view of split-steering column, showing unfinished interior clamp and shaft.
